Independent Enquiry
Into Casuarina Substation Events
And Substation Maintenance across Darwin

Preliminary Report

10th November 2008

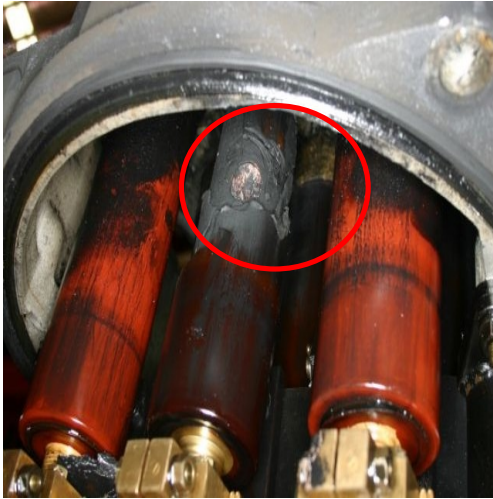
Fig 1 – Damage to Circuit Breaker Bushing

Close inspection of the breaker revealed evidence of a breakdown in the electrical insulation of the B phase transformer circuit breaker bushing. The breakdown occurred between the active conductor within the bushing and the external steel housing of the breaker tank, at the position of the pressure vent, just above the oil level.

The condition of the electrical insulating papers adjacent to the point of failure was dry and flaky and exhibited the characteristic signs of delamination due to long term heat exposure. Neither the primary isolating contacts nor the main contacts however showed any significant signs of discolouration, typical of overheating.

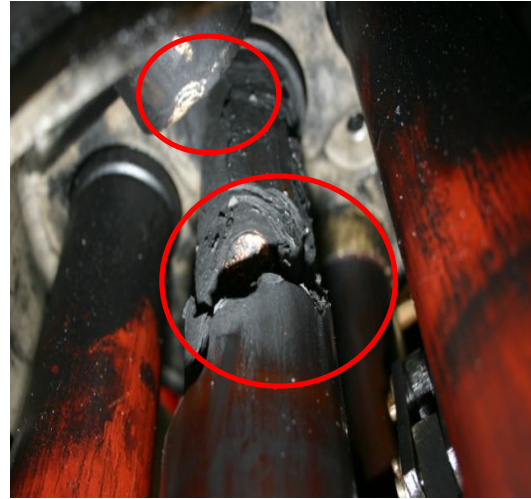
Fig 2 – Evidence of Flashover from Bushing to Tank

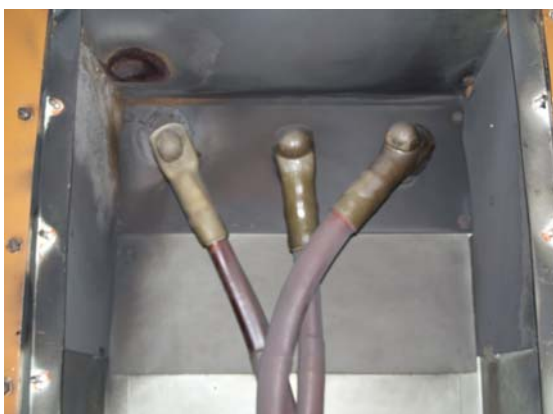
Inspection of the recovered first failed bushing revealed that insulation breakdown had occurred at the point where the bushing passed through the inner steel casing and insulating barrier of the busbar chamber.

Fig 1 – View of the endbox showing the cables bolted to the ends of the bushings and covered by heat shrink boots. The failed bushing is in the left. Note the burn mark above.

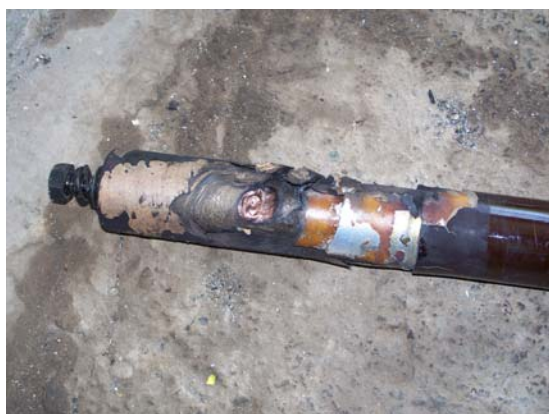
Fig 2 – Close up of the damaged bushing showing the position of the puncture through the bushing insulation.

it is considered most likely that the insulation of the first bushing, having suffered considerable environmental degradation throughout its life, finally failed due to “thermal runaway”, triggered by elevated temperature. It is also possible that the bushing may have suffered surface damage inflicted accidentally during some previous maintenance or repair activity.

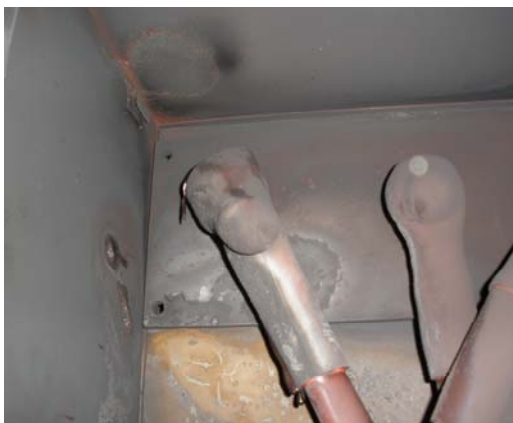
Because of the access restrictions imposed following the earlier failures, the second failed bushing was not available for inspection; however examination of photographic evidence, taken at the time of the failure revealed a different pattern of failure. Significant damage was apparent at the end of the bushing immediately adjacent to the cable attachment, beneath the “heat shrink” boot which insulates the cable connection.

Fig 3 – View of the endbox showing the cables bolted to the ends of the bushings and covered by heat shrink boots. The damage to the LHS cable end and insulating boot is apparent.

Examination of the photographic evidence also suggests the possibility that the heat shrink boot may not have been fully shrunk and that other internal componentry may not have been properly fitted.

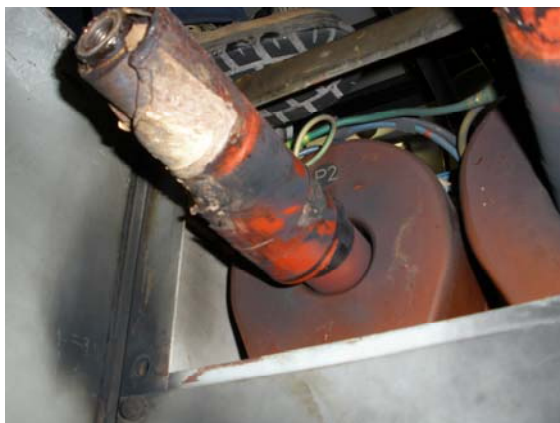
Fig 4 – Close up of the damage to the end of the Bushing. (The rear plate of the endbox has been removed)

The location of the damage caused by the failure is at the end of the bushing (immediately adjacent to the cable attachment, beneath the “heat shrink” boot which insulates the cable connection), where the electrical stress across the bushing insulation is least. Failure at this location, occurring as it has shortly following re-installation, is almost certain to be due either to mechanical damage or, some other installation defect. In this case it is most likely that the failure was triggered by mechanical damage to the surface treatment and possibly also the outer papers of the bushing, inflicted accidentally at the time of its removal from the Wagaman Feeder endbox. Elevated temperature may also have had a part to play.

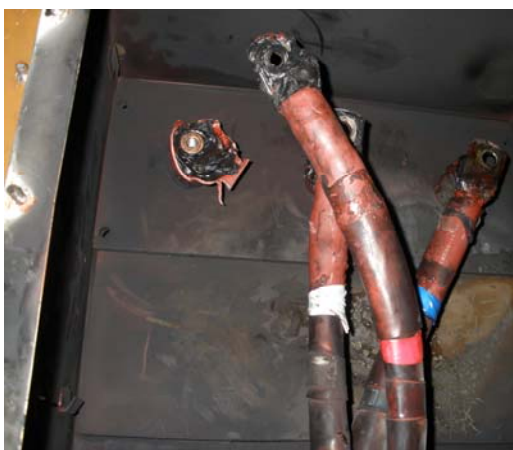
Fig 5 – View of the endbox. The damaged C phase bushing is on the (LHS). The cables have been unbolted from the bushings. The heat shrink boots have been removed.

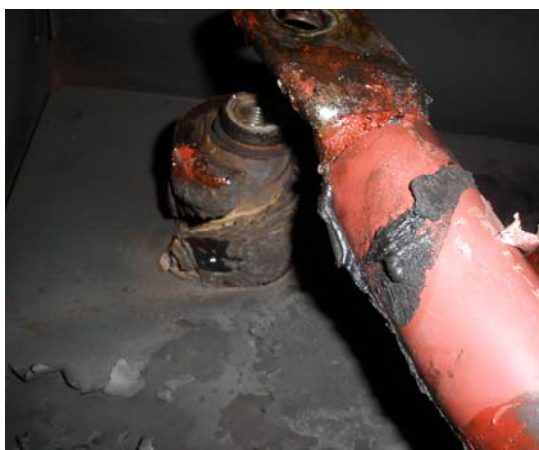
Fig 6 – Close up of the damage to the end of the Bushing and the cable termination. (The rear plate of the endbox is still in position)

Mechanical damage of the type envisaged (scoring with a knife) would permit moisture ingress and be sufficient to trigger failure in an otherwise un-degraded bushing. Failure of a degraded bushing would simply occur more quickly.
