**Independent Enquiry**  
**Into Casuarina Substation Events**  
**And Substation Maintenance across Darwin**

**Final Report**

**4<sup>th</sup> February 2009**

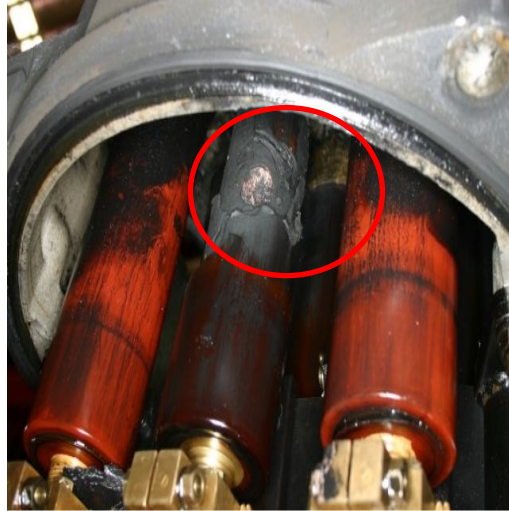
**Fig 1 – Damage to Circuit Breaker Bushing at the point of failure inside the tank**

Close inspection of the breaker revealed evidence of a breakdown in the electrical insulation of the B (yellow) phase transformer circuit breaker bushing. The breakdown occurred between the active conductor within the bushing and the external cast metal housing of the breaker tank, at the position of the pressure vent, just above the oil level.

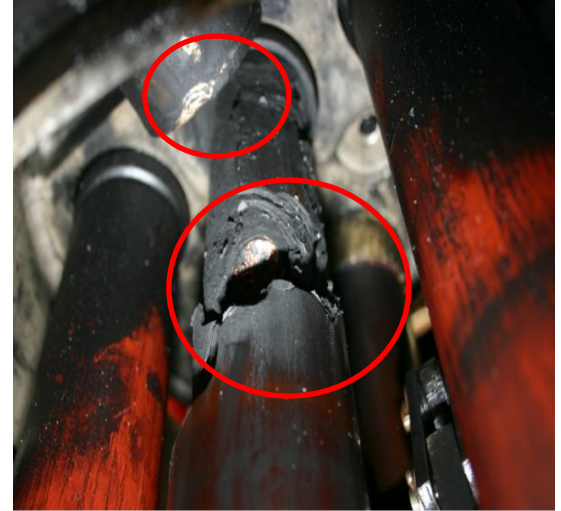
**Fig 2 – Evidence of Flashover from Bushing to tank**

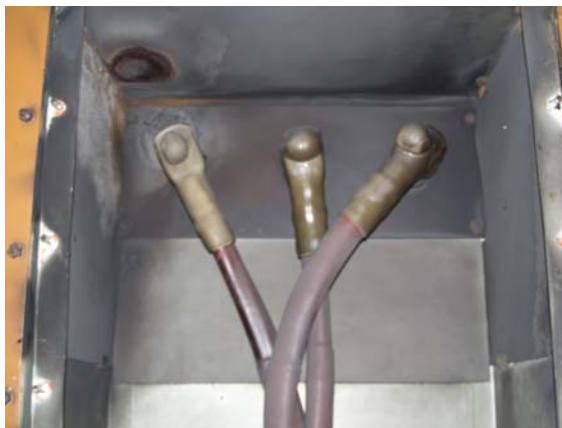
**Fig 5 – View of the endbox showing the cables bolted to the ends of the bushings and covered by heat shrink boots. The failed C phase bushing is on the left. Note the burn mark above.**

**Photographs** of the endbox clearly show an electrical burn mark on the back left hand corner of the steel ceiling of the endbox.

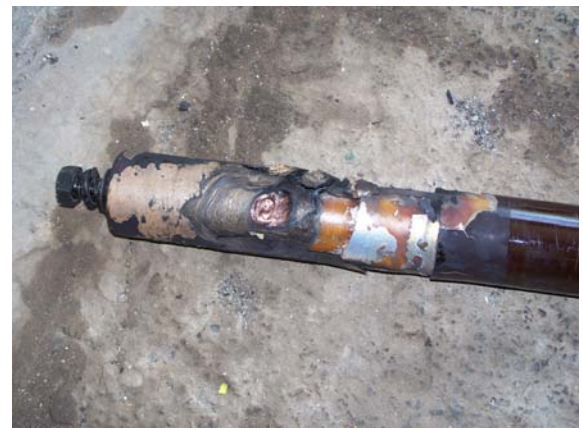
**Examination** of the recovered first failed bushing revealed that insulation breakdown had occurred at the point midway between the earth ring and the end of the bushing, well in front of where the bushing passes through the Bakelite insulating barrier at the back of the busbar chamber.

**Fig 6 – Close up of the damaged bushing showing the position of the puncture through the bushing insulation.**

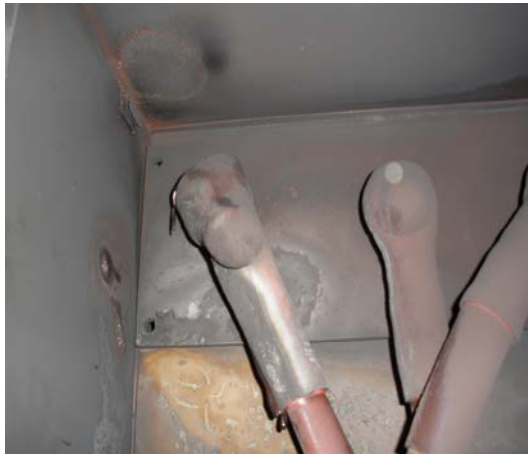
**Fig 11 – View of the LHS of the endbox showing damage and missing components.**

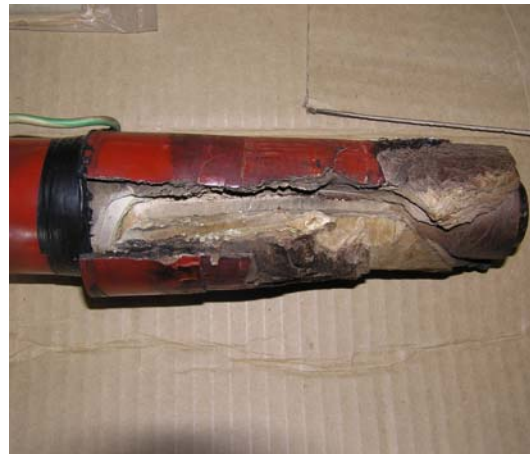
**Examination** of the second failed bushing revealed a different pattern of failure. Significant damage was apparent at the end of the bushing immediately adjacent to the cable attachment, beneath the “heat shrink” boot which insulates the cable connection. Despite considerable tearing of the insulation there was little evidence of arcing to the busbar itself. Moreover a second puncture is apparent further along the bushing.

**Fig 7 – View of the damaged C phase bushing, showing the full length tear.**

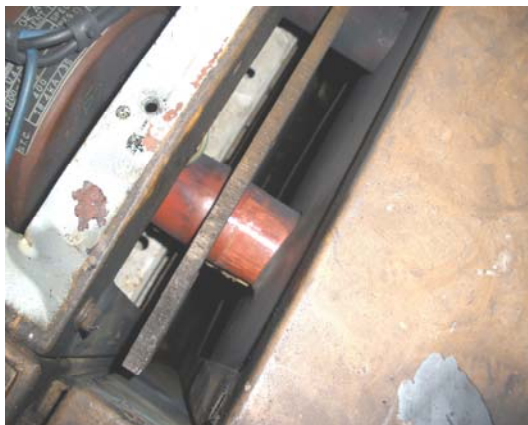
**Fig 15 – View from the top, showing that the endbox has come adrift from the CT chamber by approximately 7.5 cm.**

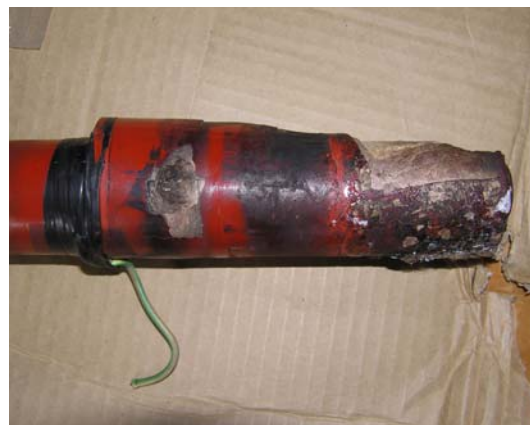
**Fig 9 – View of the damaged C phase bushing, from the other side, showing the shallow second puncture clearly visible 13.3 cm from the end.**

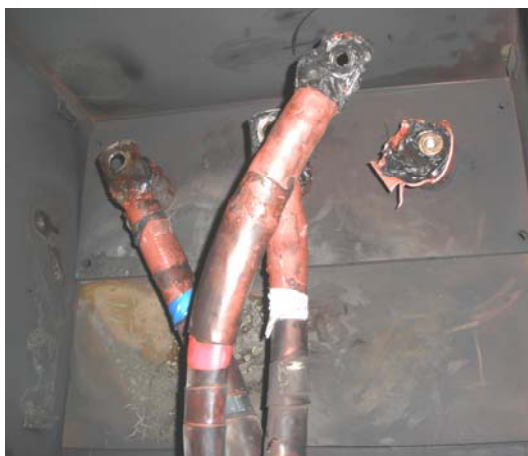
**Fig 13 – View of the endbox. The damaged C phase bushing is on the (LHS). The cables have been unbolted and the heat shrink boots removed.**

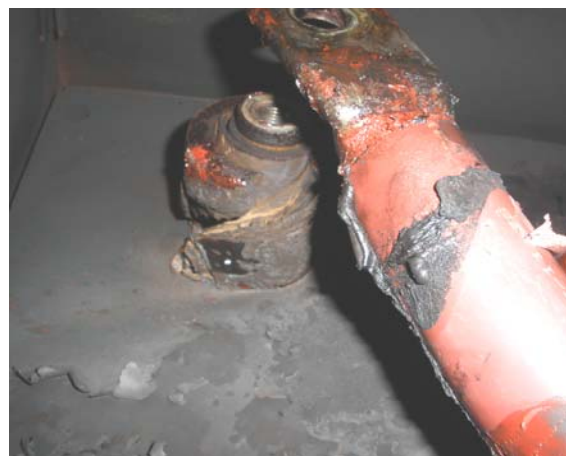
**Fig 14 – Close up of the damage to the end of the C phase bushing and the cable termination. (The rear Bakelite plate of the endbox is still in position)**

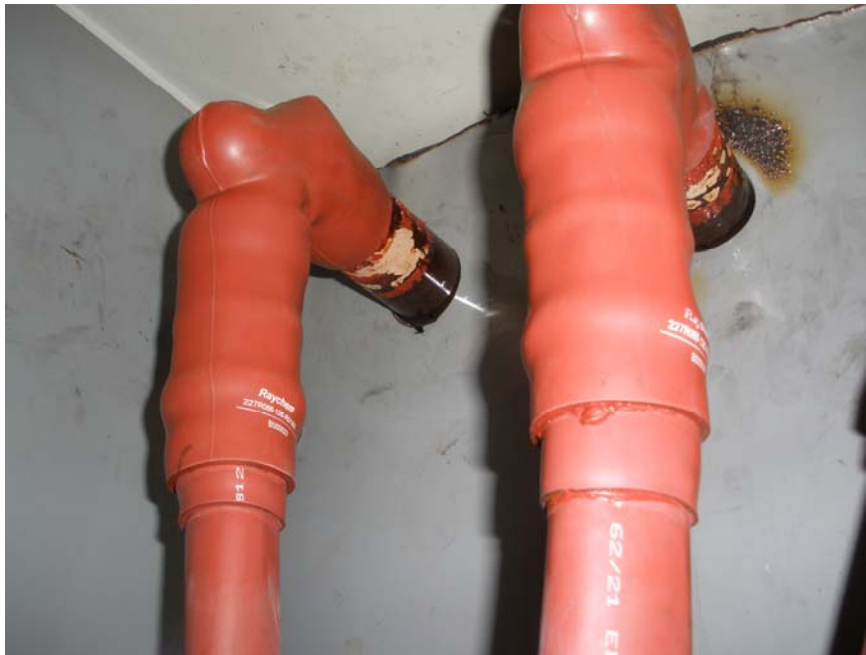
Photographic evidence was also available of the external appearance and condition of some of the other “in service” endbox bushings of the No3 Busbar Section. These photographs were taken during the recovery work following the second failure. The most notable of these are shown below.

FAC Feeder Endbox bushings and cable terminations. (A and B phase only).
